Mobile Pentium® II Processor Specification Update

Release Date: February 2000

Order Number: 243887-018

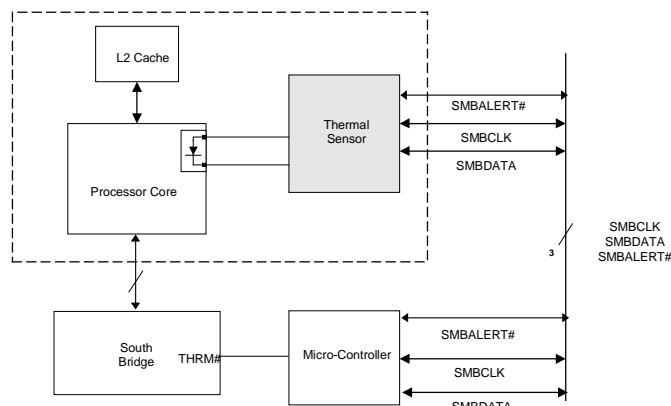
Figure 1. An Example of Microcontroller Driven Thermal Management

B30. Thermal Sensor May Assert SMBALERT# Incorrectly

Problem: The Mobile Pentium II processor and the Pentium II Processor Mobile Module have a thermal sensor that monitors the processor core's temperature. Please note that desktop systems could have a similar thermal device. The thermal sensor asserts SMBALERT# if the processor temperature exceeds the temperature limits set in the Alarm Threshold Registers (T_{HIGH} , T_{LOW}). It also sets the corresponding Status Register bits to identify the cause of the interrupt. Figure 1 gives one example of the how the SMBALERT# signal could be used in a system.

Under the conditions described below, the thermal sensor incorrectly generates the SMBALERT# interrupt. All of the following conditions must be met to trigger a false interrupt:

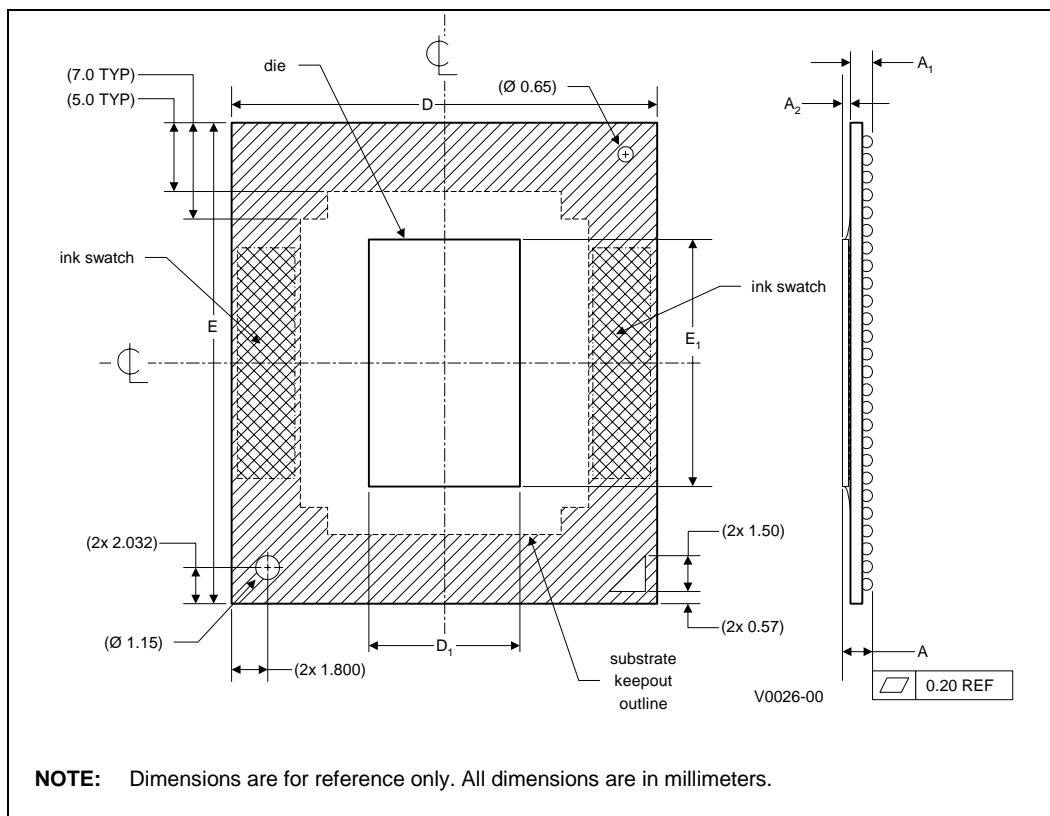
Figure 5.3. Surface-Mount BGA1 Package—Top and Side View

The following table and figures show the updated mechanical specifications for the BGA1 package, listed as Table 5.2, Figure 5.3 and Figure 5.4, respectively, in the *Mobile Pentium® II Processor in BGA Package at 366 MHz, 333 MHz, 300PE MHz, and 266PE MHz* datasheet.

1. The number shown here is different from that in the 243887-010 revision of this specification update. The maximum reference number is used.
